Borough House (Hill Crest)
Dependency (Weaving House)
W. side of State Rt. 261, about .1 mi. S. of
Junction with old Garners Ferry Road
Stateburg
Sumter County
South Carolina

HABS No. SC-368

~~Addendum to~~
~~Borough House (Mill Creek),~~
~~Dependency (Weaving House)~~ HABS No. SC-368

Location: Part of the Borough House plantation complex on west side of State Route 261, 0.8 mile north of intersection of Route 261 and State Route 76-378; Stateburg, Sumter County, South Carolina

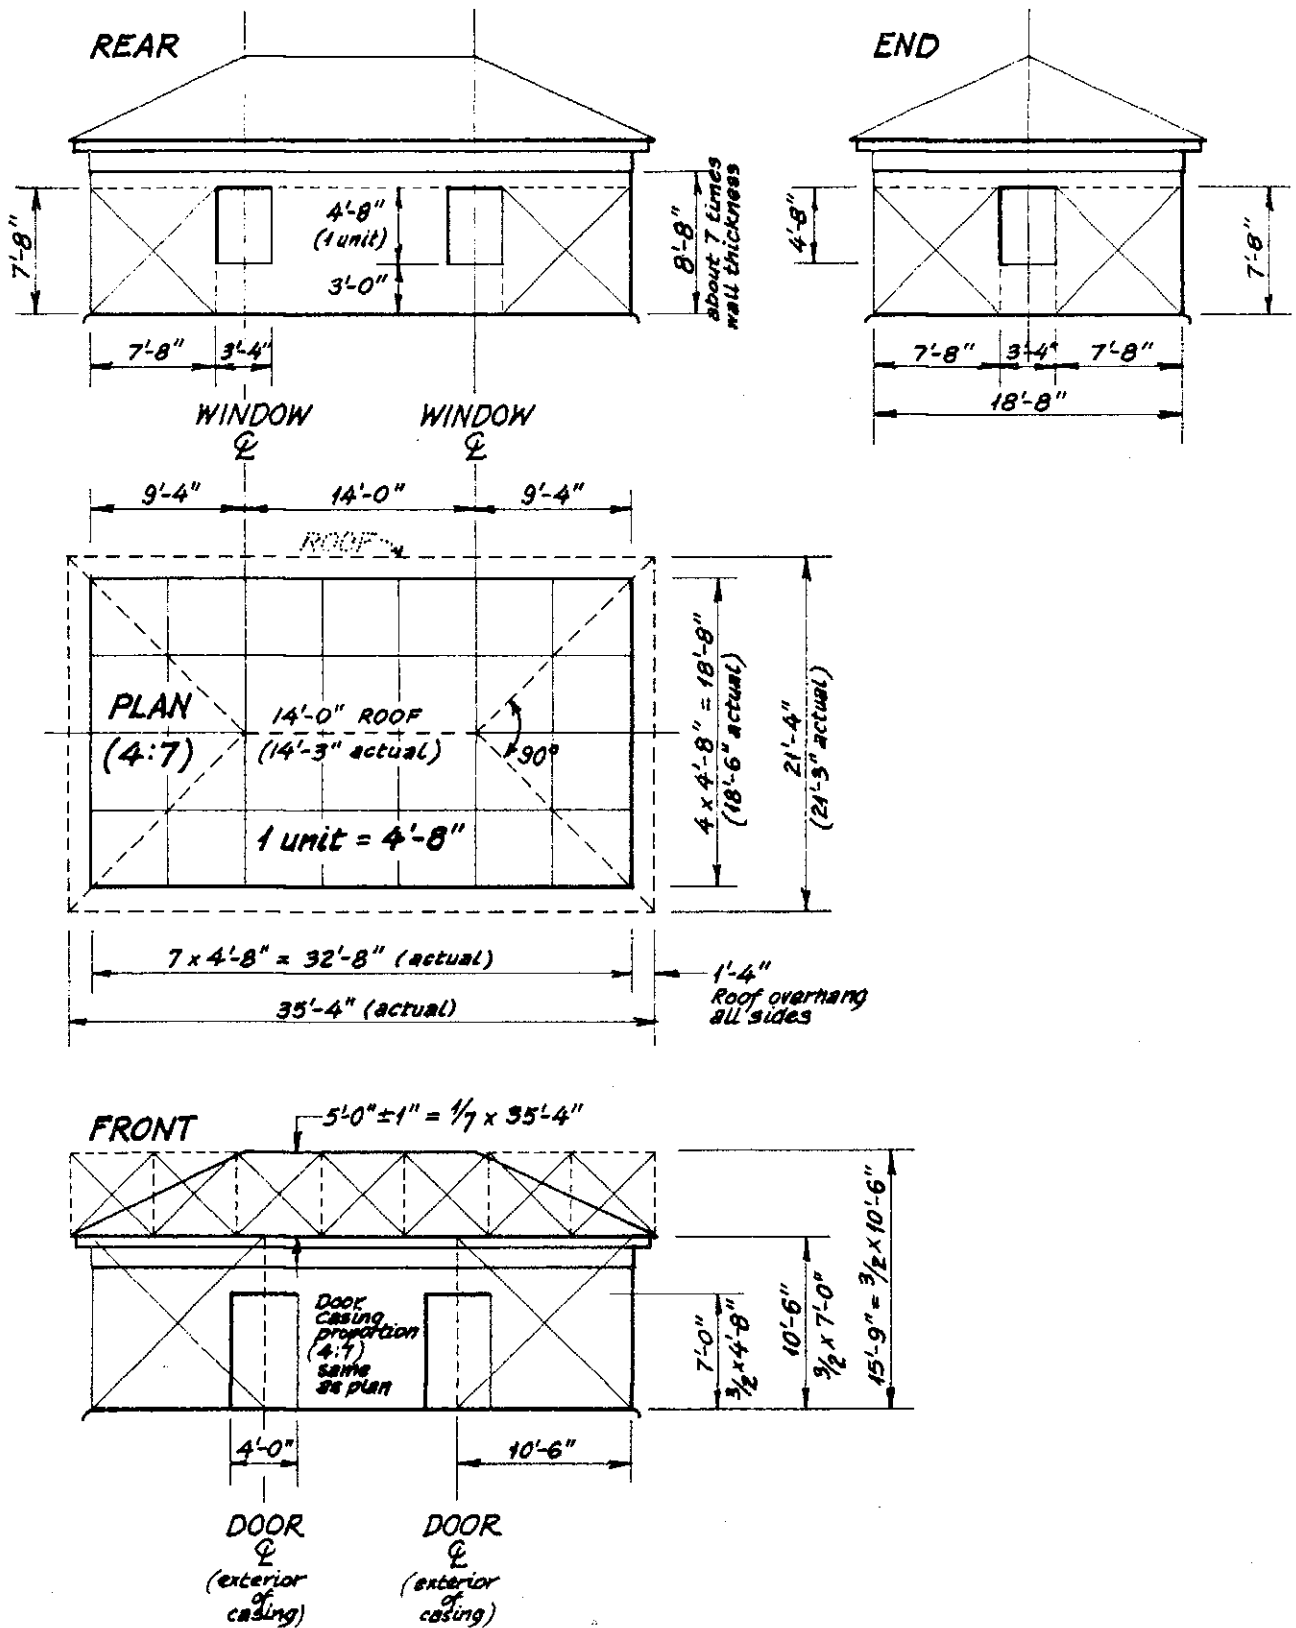
If a grid of 4'-8" squares is laid over the building plan, it is apparent that the window centerlines on the back (west) facade are $\frac{2}{7}$ of the building length from the ends. The windows on the ends are centered in a facade $\frac{4}{7}$ as long as the building, or $\frac{2}{7}$ from the corners. The ridge of the hip roof is nearly

$\frac{3}{7}$ the length of the building; thus the hips intersect the ridge at points $\frac{2}{7}$ from the ends and sides, putting the roof hips at 45° angles in projection (plan). The window casings are 4'-8" high, and the door casings $1\frac{1}{2}$ times this height, or 7'-0". (Since the door casings are 4'-0" wide, this makes the door casings 7:4 rectangles, same as the building plan.) Interestingly, the tops of the window casings are 7'-8" from the tops of the foundations; this is the same as the horizontal dimension from the corners of the building to the nearest window casing edges (see page 4). The centerlines of the doors, however, do not line up at points $\frac{2}{7}$ along the front facade. They are instead centered 10'-6" from the corners, which also happens to be the height of the roof drip from the foundations and $1\frac{1}{2}$ times the height of the door casings.

Despite its utilitarian appearance, the Weaving House appears to have been the subject of intense classical geometric design work. In plan, the lengths of the building's sides are in the ratio of 7:4, allowing for minor construction error (the 18'-6" sides are 2" shorter than this ratio requires for a building 32'-8" long). These and many other dimensions are multiples of a basic unit of 4'-8".

The height of the entablature above the foundation is a bit of a mystery in the midst of the other relationships. The 8'-8" dimension does not seem to be a multiple of anything, except that it is very close to being 7 times the wall thickness (1'-2" to 1'-3"). It is also close to being $\frac{5}{6}$ of the height to the roof drip, which would be a proper Palladian proportion if columns stood under the entablature.

The overall height of the building is within 3 inches of being $1\frac{1}{2}$ times the height of the roof drip from the foundation top; this is $(1\frac{1}{2})^2$ times the height of the door casings, and $(1\frac{1}{2})^3$ times 4'-8". The roof itself, a bit longer than the building at 35'-4", is 7 times as long as it is high, within the error allowed in measuring the roof height.
